Near Miss Event Incident Report

Gas detection alarmed on high Carbon Monoxide (CO) inside a High Pressure Distillation Column (T-1502)

4TH APRIL 2015

T-1502 HP Distillation Column

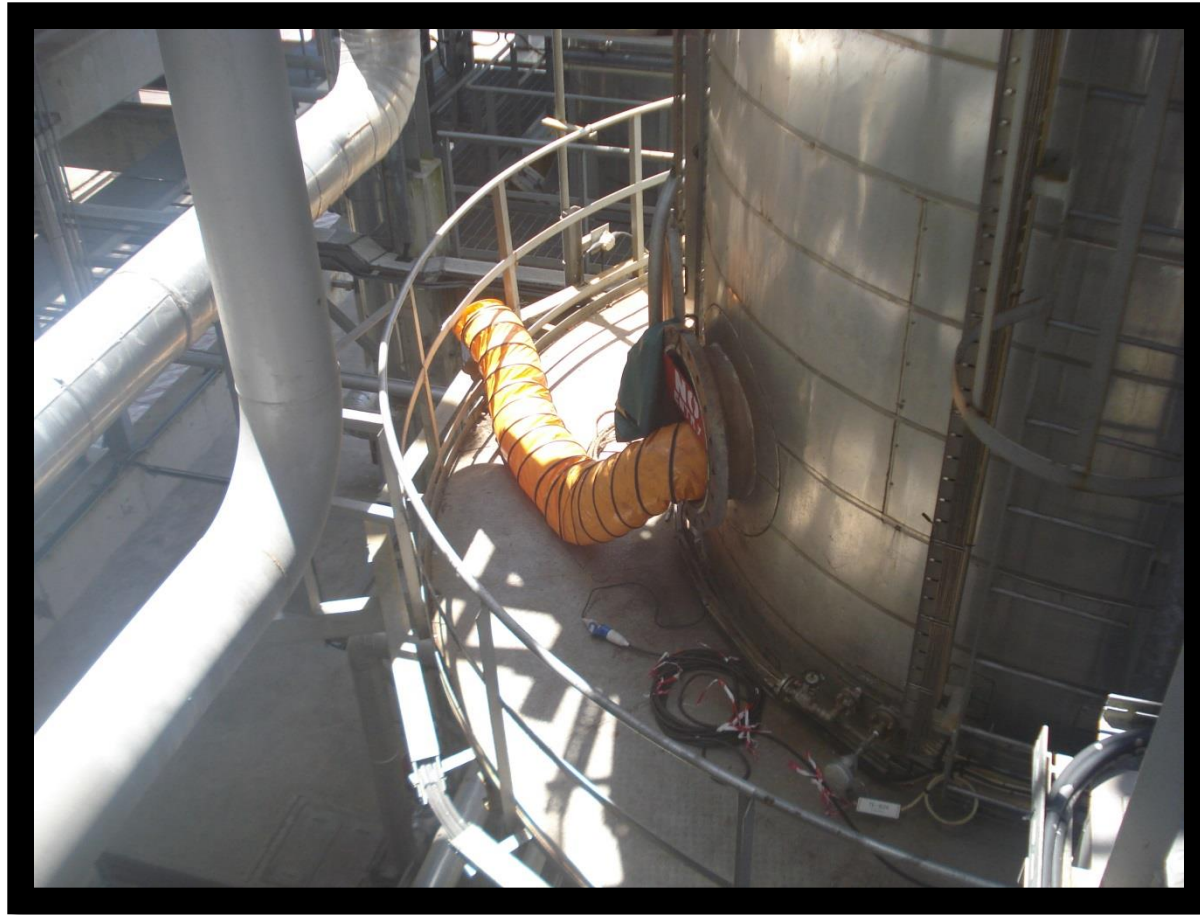
Figure 1: Blower Used at the Bottom of T-1502

- Inadequate ventilation of the column
- ✓ There was no evidence to suggest T-1502 was continuously air purged after the make safe condition, although two air blowers (refer to figure 1&2) were used for the push and pull of air at the bottom and middle manhole.
- ✓ Air circulation was not continuous.
- ✓ Air blower was only used intermittently and the equipment was considered inadequate for that kind of service.

1. Update the make safe condition procedure to emphasize positive isolation for HP distillation Column instead of entire distillation section. (refer to Appendix 1)
2. Update the make safe condition procedure to include a minimum of 72 hours continuous push and pull air purge of T-1502 before entry.
3. Upgrade the four head gas monitoring device.
4. Include in the make safe procedure;
The use of Tiger VOC detector, as part of the make safe assurance from methanol residue.
5. Update the Incident Investigation Procedure to provide clear guideline for all near miss reporting and follow up.
6. Train the operations team on the updated near miss reporting protocol.

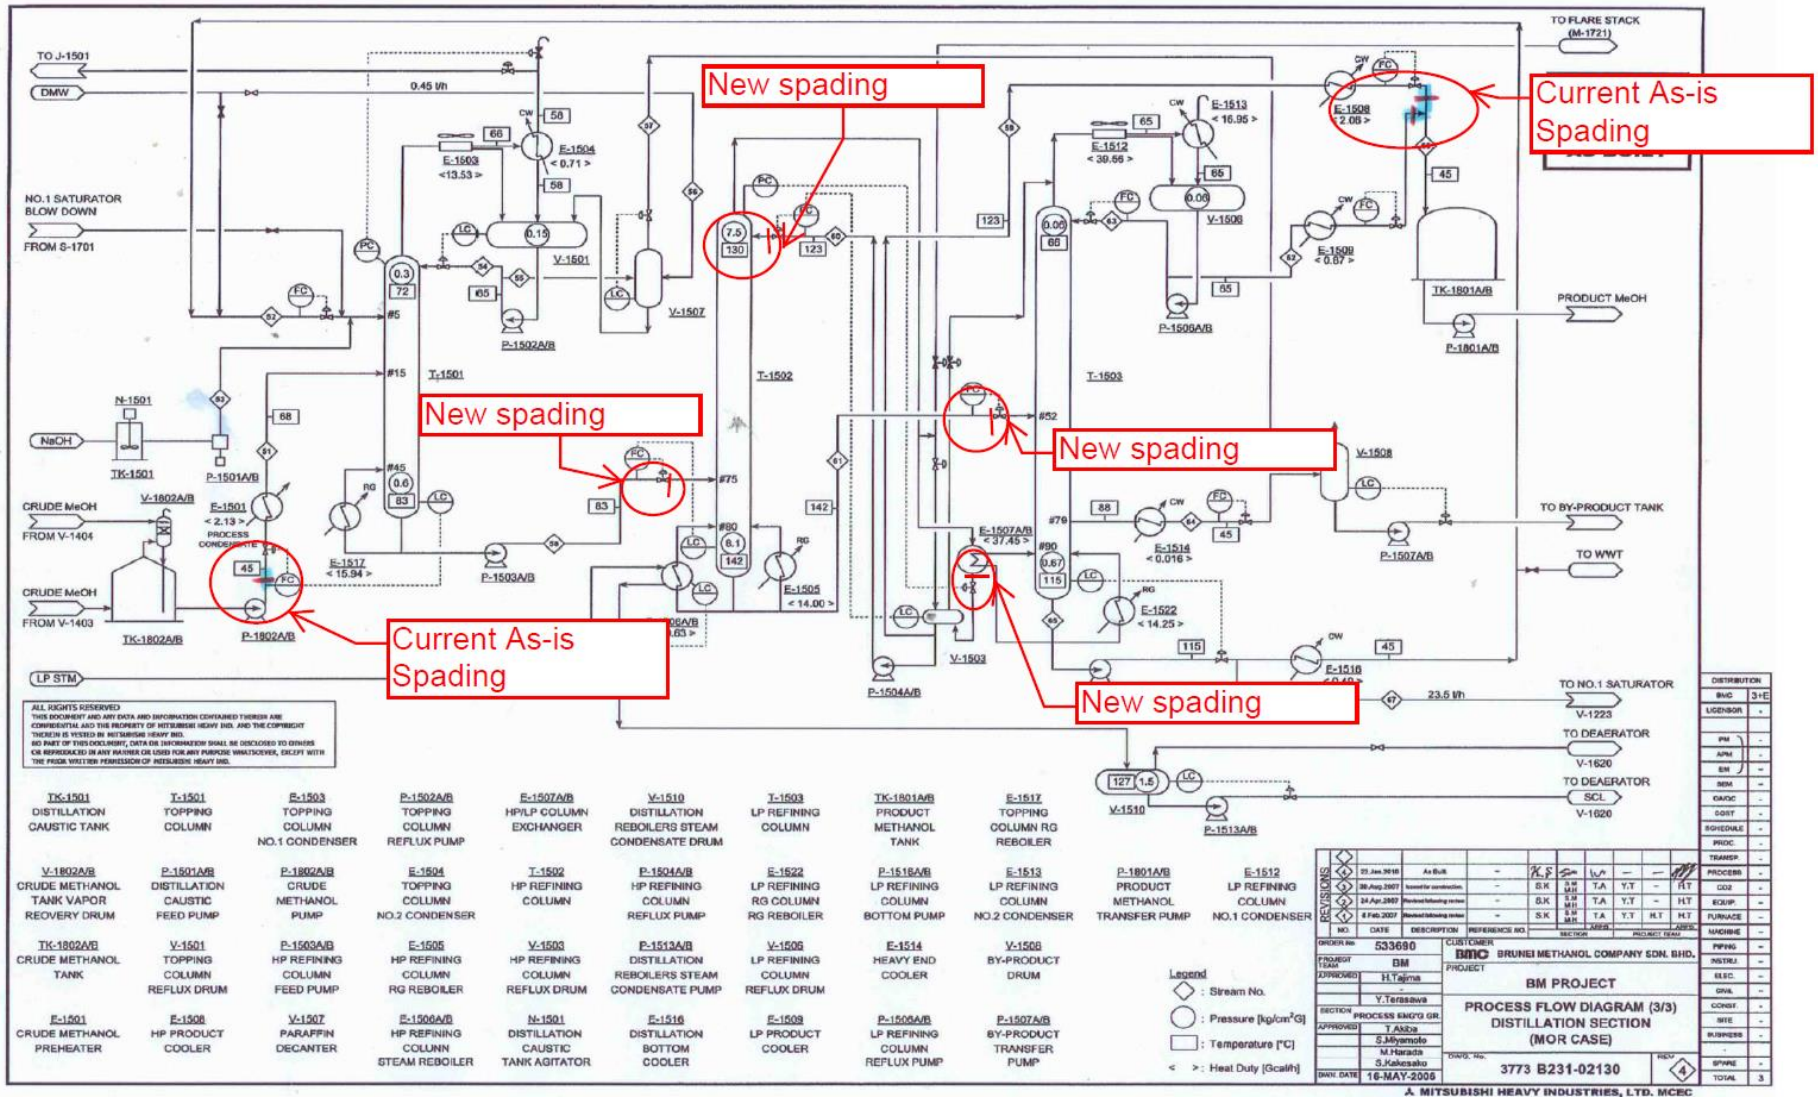
Isolation Points of Distillation Section as Part of Make Safe and New Spading Points

- ✓ The isolation was made for the entire distillation section instead of providing positive isolation specific to HP Column unit as part of the make safe condition(refer to appendix for the marked up drawing) .
