LEARNING FROM INCIDENT

Reinforced Thermo-Plastic (RTP) Line Rupture Incident

Dr HJh Siti Haziah POKSMDSP HJ Abidin
Head, HSSE and Crisis Management
Brunei Shell Petroleum Company Sdn Bhd
11/11/15

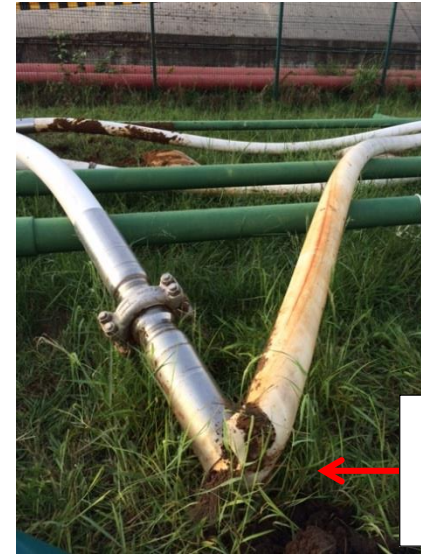
Ruptured at
interface of
grayloc
connection

- Rupture resulted from significant and cyclic deformation leading to rapid failure of the wire armour reinforcement of the RTP line
- Some root causes include:
 - Design- not accounted for future pigging operations
 - Management of change (MOC) – lack of recognition on the need
 - Boundary conditions – failure to confirm
 - Risk Awareness – lack of consideration of impact of high DP
 - Supervision and communication – lack of effective team coordination and unclear accountabilities and responsibilities

- Key risks were missed / underestimated . It is essential that when conducting complex activities that a thorough risk assessment involving suitably independent and experienced / qualified personnel is completed to ensure the potential for missing or underestimating risk elements is minimised
- REMEMBER **PAUSE** - What has changed? (**P**eople **A**ctivities **U**nexpected events **S**cope **E**xposures)

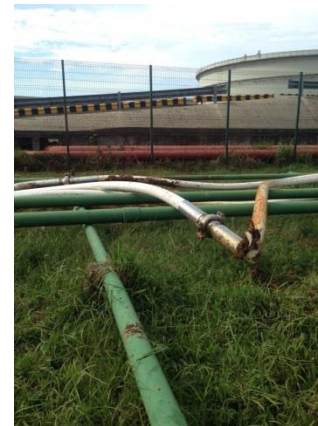
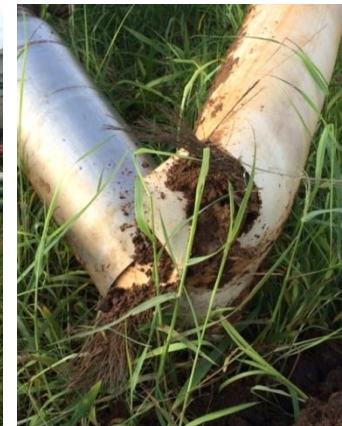
- On 2nd April, 2015 during wax cleaning operations, a continuous attempt was made to recover a stuck foam pig within an RTP oil transfer line using high pressure pump.
- While applying pressure of approximately 110 bar the line ruptured adjacent to a grayloc connection point next to a public road.
- No injury occurred and minimal impact to environment were reported as the line had been flushed with water and only residual wax remained. The line was also disconnected from the process line during the activity. At least one member of the public had their vehicle impacted by wax as they passed the incident site.
