LEARNING FROM INCIDENTS NEWSFLASH

BSP-NF-201357

TWC – AMDP17 – BSP Well Services Wireline

Wireline crew hurt wrist in AMDP17

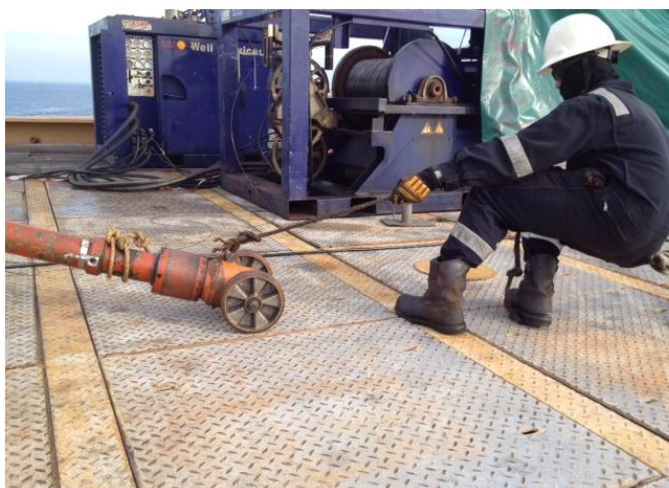
On the 22nd of September 2013 at 0400hrs, a wireline crew had rig down lubricators having suspended intervention activities on the well SWA-276L (AMDP-17). During pulling the lubricator away from the K-lift Crane, the IP lost his grip and lost his balance which caused him to fall down. Using both his hands to support him from falling to the floor, he put more weight on his right hand and thus hurting his wrist.

- What is the condition of your PPE before you start your job? Ok to proceed?
- What are Manual handling techniques? They include pulling and pushing as well, not just lifting only.
- What is routine activity? Are those things done routinely always safe?
