LEARNING FROM INCIDENTS NEWSFLASH

BSP-NF-201361

BSP – Well Engineering & Well Services

Step ladder blown off from platform

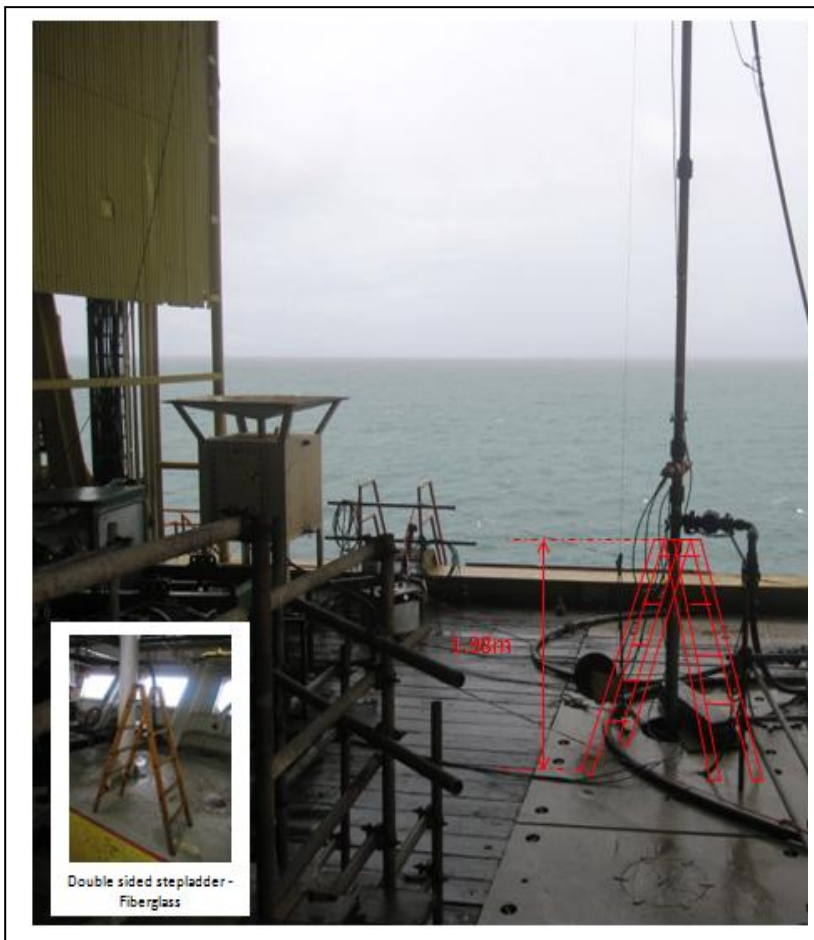
On 12th October, 2013 at 0100 hours slickline crew were working on SWA-306 at AMDP 25 while drilling crew were engaged in setting a shallow plug for temporary abandonment of SWA-314 two slots away on the same platform. With a sudden squall hitting the platform, a double sided stepladder made of fibreglass weighing 11.8 kg used by the slickline crew for operating valves and BOP on the platform top deck, was blown away into the sea.

- Are all equipments secured?
- Do we understand change management?
- Do we have due considerations for weather conditions and their impact on operations?
