## IMCA Safety Flash 16/13

October 2013

## 2 Fatality – Man Overboard

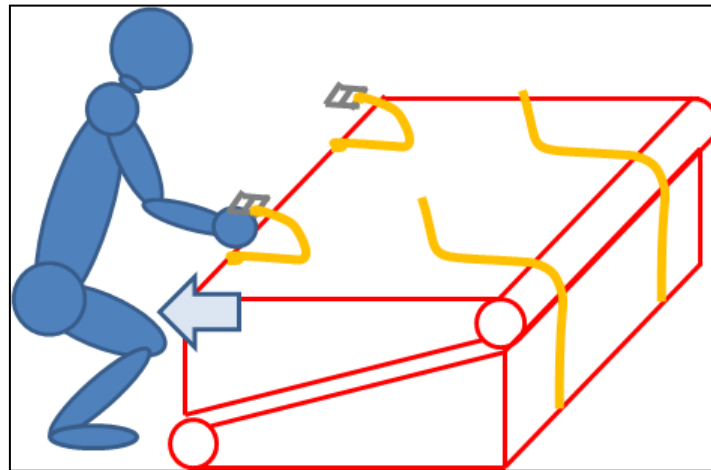
*Position of worker as upper element started to move*

- ◆ The area where the injured person was working (3m away from side) had been previously risk assessed as “safe” with regard to the risk of falling into the sea, and so the requirement for a life jacket had not been identified for the task;
- ◆ During the operation, the worker was positioned “in the line of fire” of the metal bulwark element on the top;
- ◆ Temporary barriers were found not appropriate, just beside the workplace of the injured person, due to a missing stanchion for holding barriers.

- ◆ A new risk assessment for bulwark removal and storage;
- ◆ Reinforce implementation of safe system of work;
- ◆ Verify vessel search light possible improvements and purchase night visors and personal locator beacons in order to improve the performance of MOB rescue;
- ◆ Replacement of missing post in port side temporary over-the-side protection;
- ◆ Increase housekeeping control on the deck;
- ◆ Complete audit and evaluation of MOB emergency procedure to be carried out utilising all required emergency equipment.

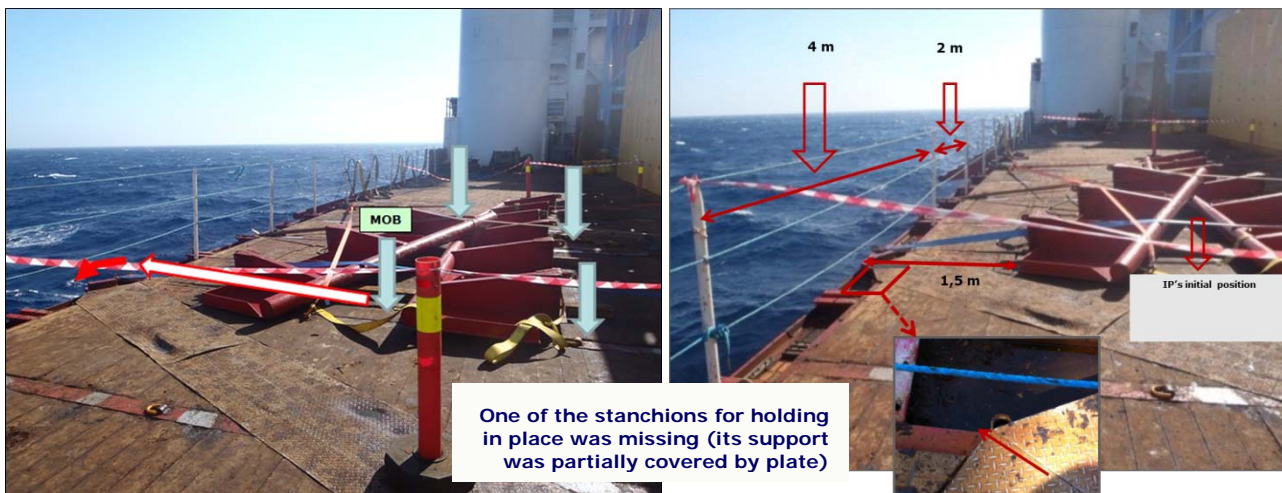
*Showing site of incident*
