LEARNING FROM INCIDENTS NEWSFLASH

BSP-NF-201358

| BSP – Well Engineering & Well Services

Aft Crane in contact with Derrick Windwall Panel

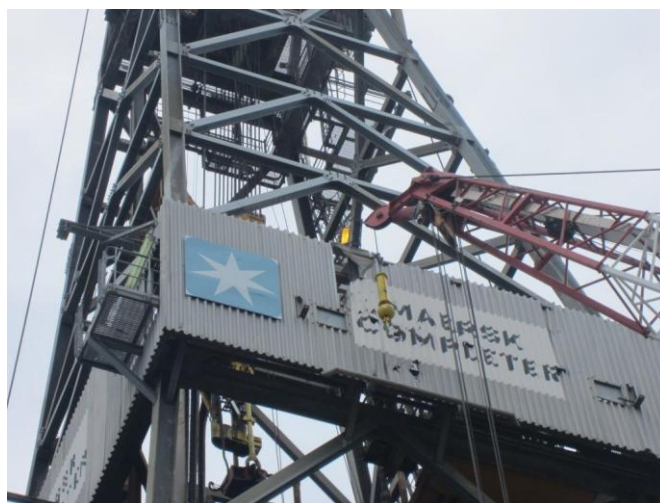
On 5th October 2013 at 8:40 am, the Aft Crane was being banked close to the Derrick to land a crossover sub on the aft part of the catwalk machine when the boom tip made contact with the Derrick Wind-wall. This impact caused a hole on the thin corrugated sheet of the forward starboard panel of the windwall to be torn upwards. No damage to any other asset, no injuries to personnel and no dropped objects..

- Is it a blind or critical lift?
- Does the JSA mention requirement of a 'spotter' in addition to the banksman?
