LEARNING FROM INCIDENTS NEWSFLASH

BSP-NF-201360

Oil Sheen incident – DD8

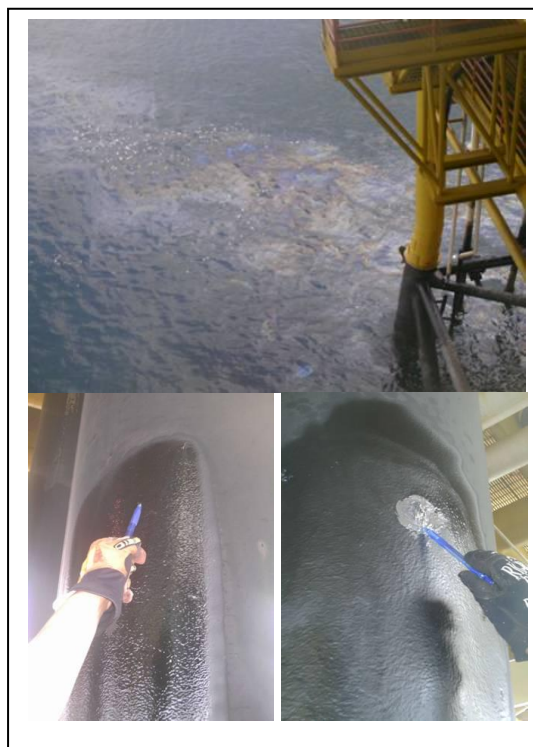
At 10:30 hrs on 9th of October 2013, sheen of oil was seen on the sea surface beside MGDPO2 platform where DD8 is drilling a well. Informed the EOP and Toolpusher and action was taken from the rig side to identify source of the leak.

When the rig went to access conductor slot #8, it was found to contain waste oil from operations. The oil was pumped into slot #5.

Preliminary investigation found that conductor slot #5 had a 1/2" hole which resulted in waste oil and water leaked to the sea forming thin oil sheen.

- Do you know your Oil spill emergency response?
- What spill response / recover equipment do you have and have you tested it?
- Have we checked the integrity of our drilling conductor?
- Always conduct regular surveillance under rigs and platforms for sheens.
- Have we included environmental aspects in our JSA?
- Waste oil should in the first instance always be taken off site rather than stored in conductors.
