LEARNING FROM INCIDENTS NEWSFLASH

BSP-NF-201365

| BSP – Wells engineering & Well Services

Parted wires around the lifting sling when lifting a jacking frame

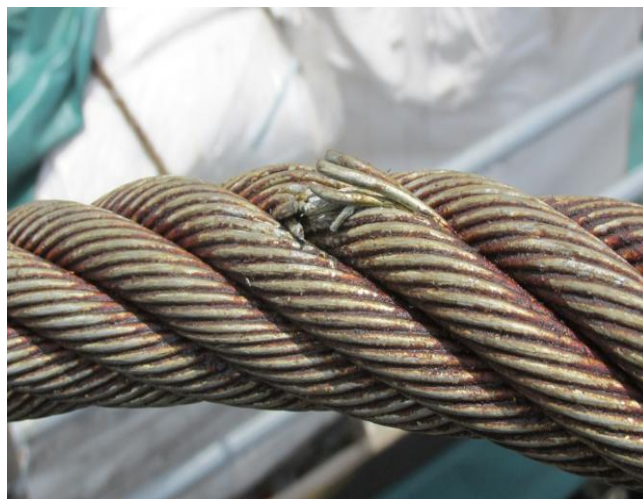
the tensions in the slings were slacked but the swell caused the crane block to swing together with the lifting slings. The crane block and slings could not be controlled to safely unhook and was hitting the gooseneck and the injector so the decision was made by the banksman to bring the jacking frame back to the vessel. After inspecting the slings and the jacking frame a few strands of wire surrounding the core of the sling were observed to have been parted. No injury was sustained by personnel during the operation.

The swell caused the crane block together with the slings to move in an oscillating motion. The slings got caught on the jacking frame, together with the impact against the injector and the gooseneck caused strands of wires to be parted on the lifting slings.

- Ensure proper communication between the involved personnel performing the lifting operation i.e. banksman, crane operator and the riggers.
- Pre-DROPs checklist must be completed prior to any lifts between the Operations supervisors and the crew.
- Ensure red zones are recognised by all personnel
- Ensure that all risks have been covered and addressed to the lifting crew together with control measures to reduce risk.
- The lifting crew must be competent to do the job.
- Inspections of all lifting equipment must be carried out prior to any lifts performed to ensure the safety of the crew.
