## Grating Incident resulting in LTI

# Incident Description

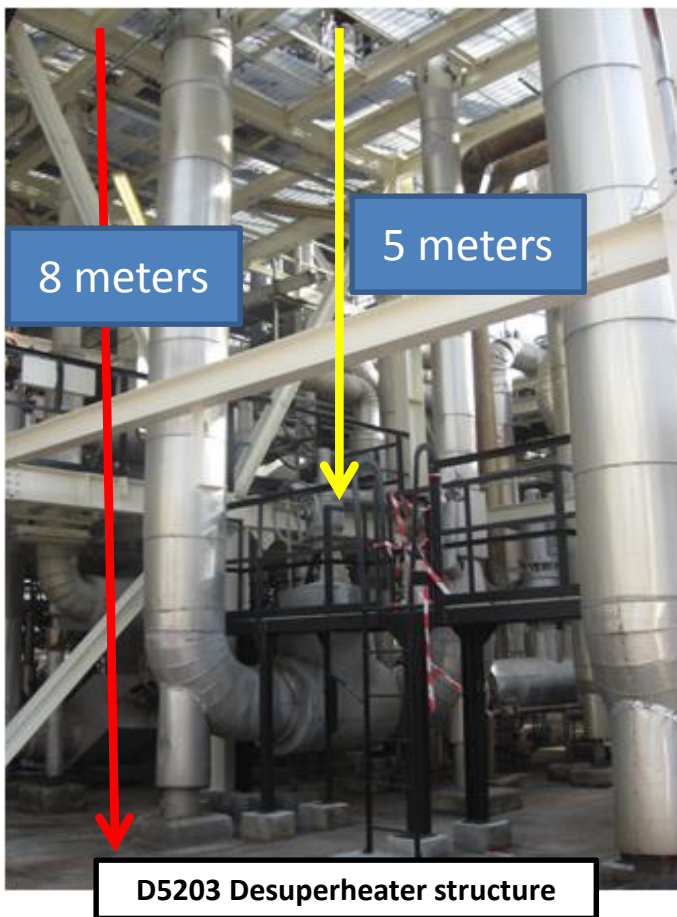
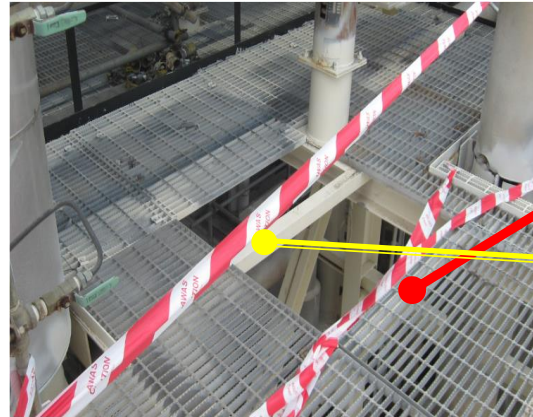
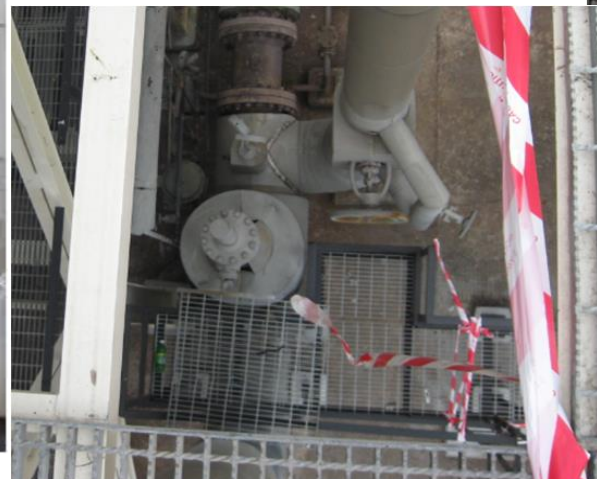
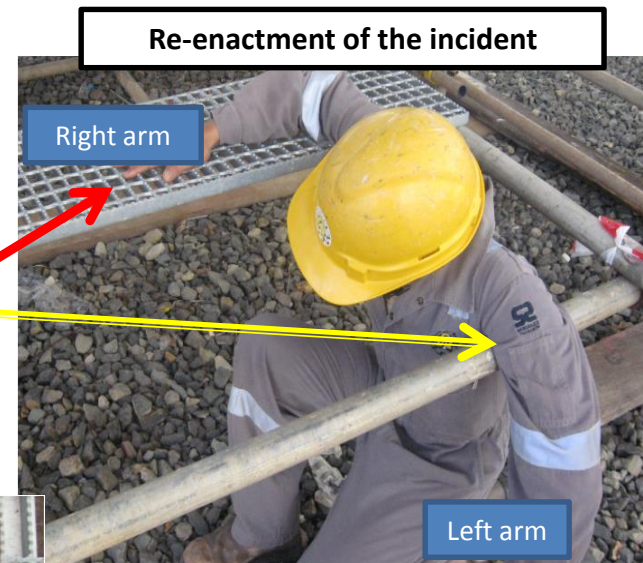
- On the 7<sup>th</sup> March 2015, three (3) scaffolders were carrying out final housekeeping on the second level platform of D5203 after scaffolding dismantling activity was completed.
- One of the scaffolders (Paryano) was picking up remaining scaffold clamps when the grating he stepped on suddenly gave way and the grating fell to the ground.
- Paryano managed to grab and hang on the I-beam and nearby gratings before being pulled out by his co-worker. He was later attended by BLNG medic and taken to the hospital for further assessment.
- The incident was classified as Lost Workday Case and reported as LTI.

Directly below the gap is a steam valve where Paryano could fatally fall

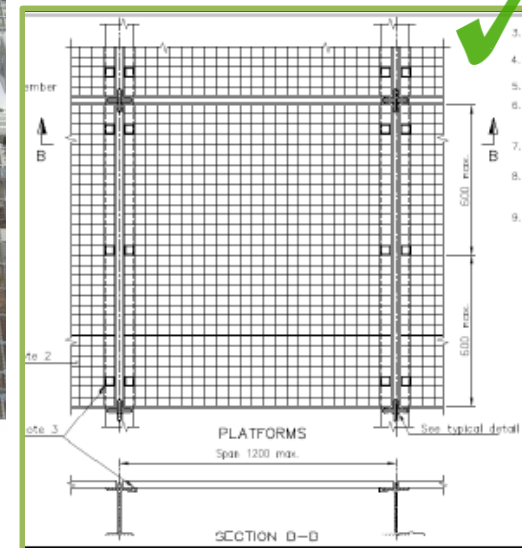
- The requirement for change of flooring from checkered plates to galvanized grating is not effectively managed (MOC or Plant Change).
- The original design was changed and the installation of platform flooring replacement did not comply with industry standards and was inherently unsafe.
- One side of the grating was barely touching the I-beam. And the other support of the grating is located in the middle. These design creates a risk of unbalance to the grating.
- There is a gap in the data and information availability with regards to changes made on the flooring design and installation after 1974.

No support found on the other side of the grating.

The other support of the grating is located in the middle.

One side of the grating was barely touching the I-beam.

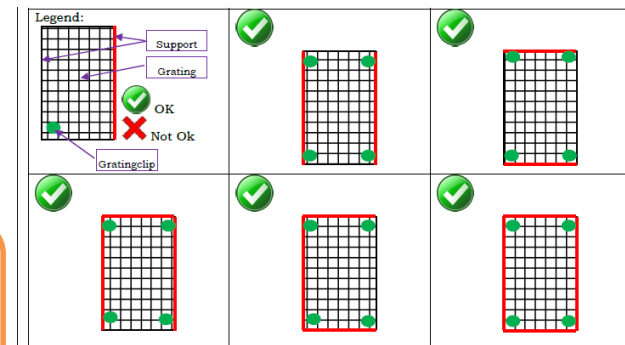
Single Span grating. Note minimum 4 clips required or 4 per m<sup>2</sup>.

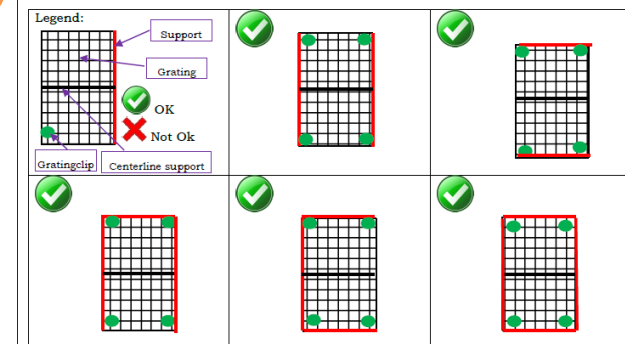
Multi-Span grating. Note minimum 4 clips required or 4 per m<sup>2</sup>. Span shall not exceed the grating design limits.

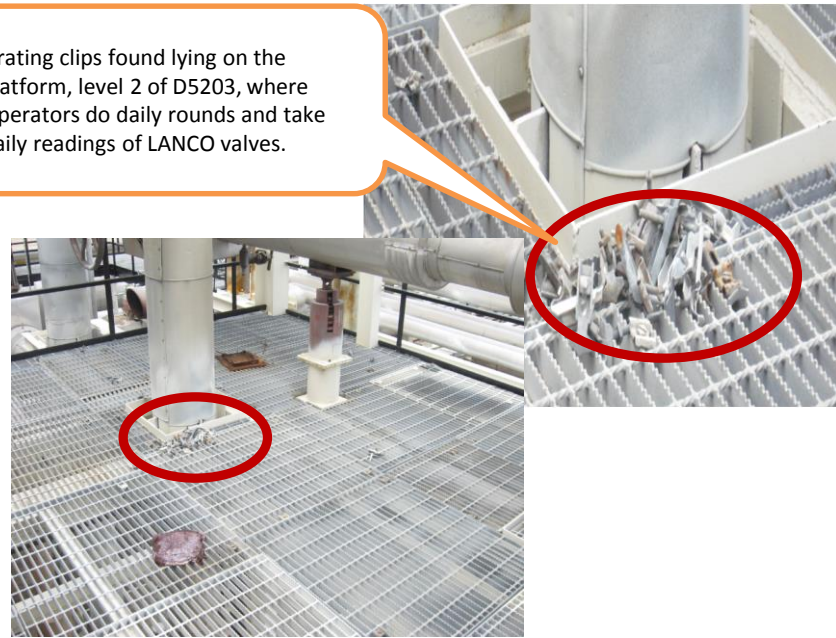
Operator's Daily Rounds at D5203

Grating clips found lying on the platform, level 2 of D5203, where Operators do daily rounds and take daily readings of LANCO valves.

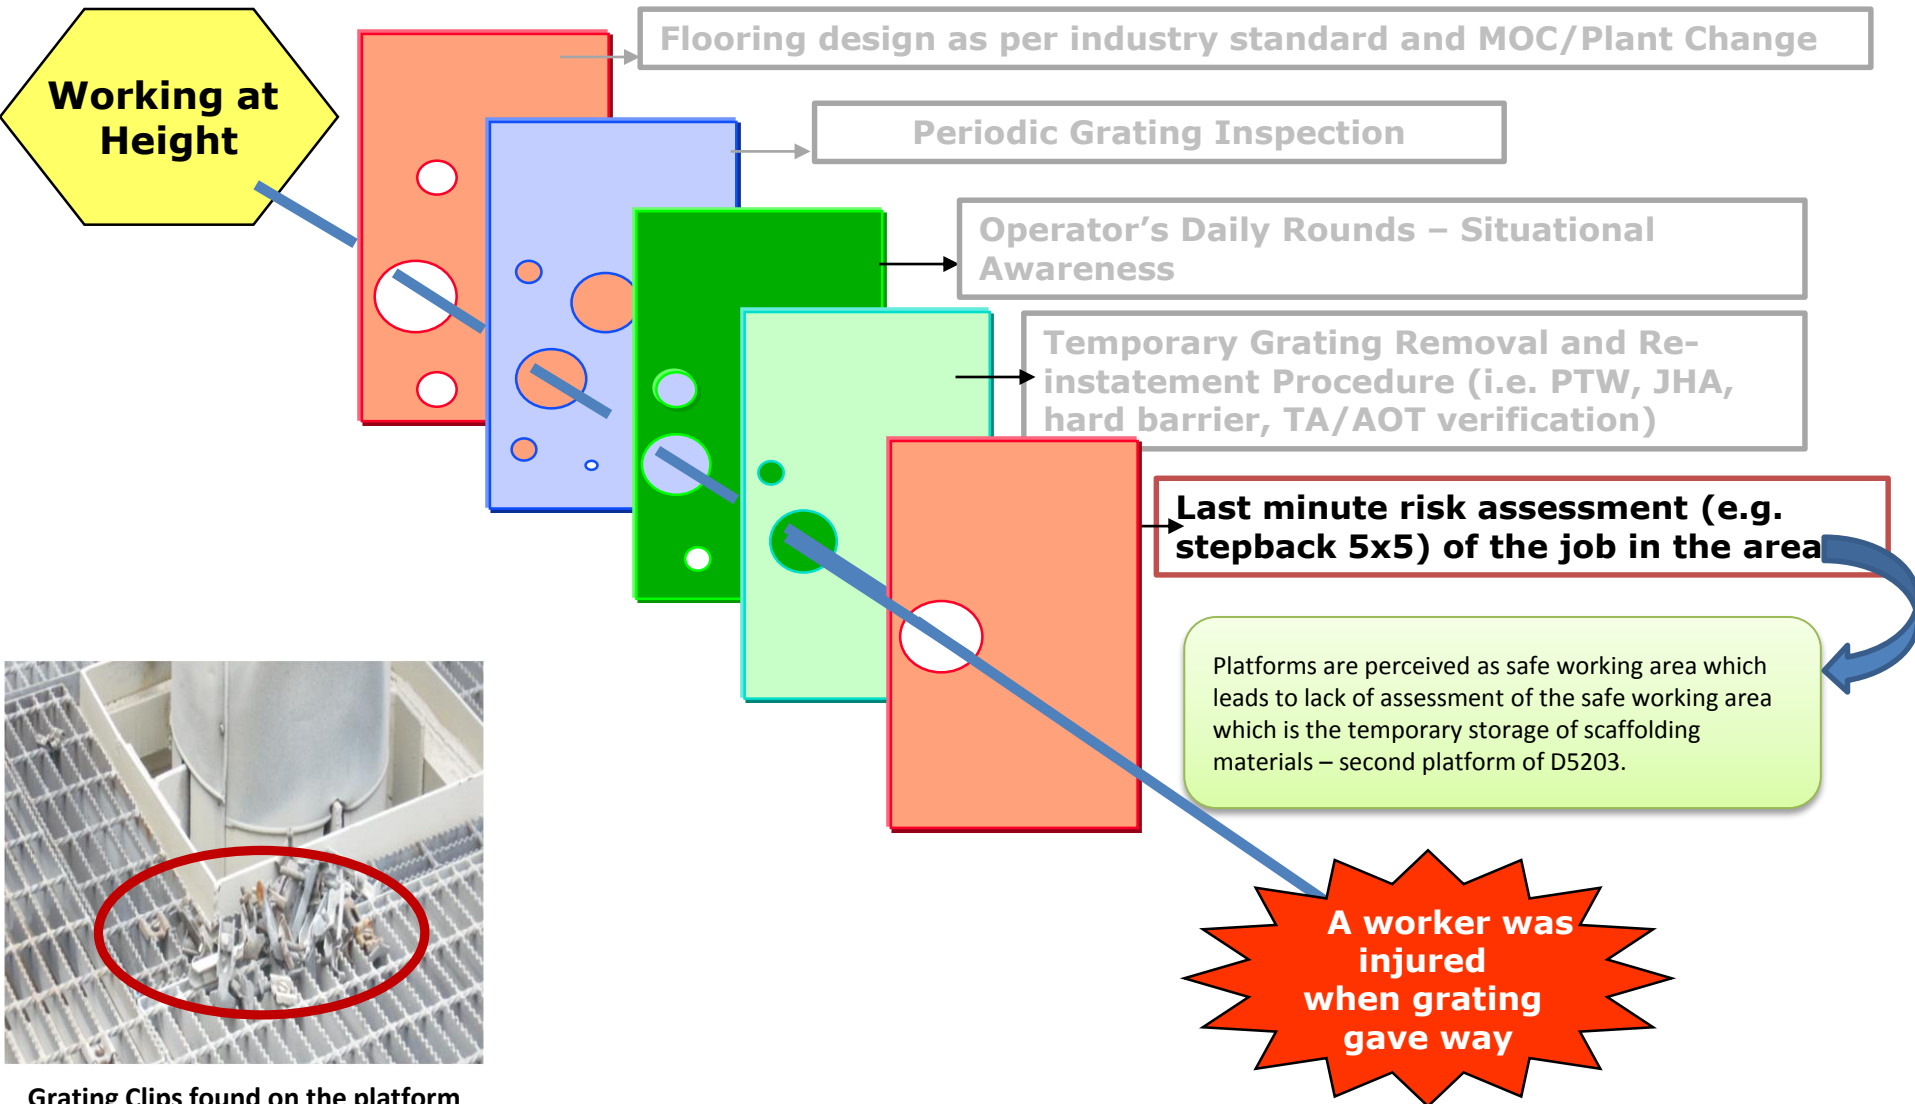
Grating Clips found on the platform
