Near Miss Event Incident Report

Gas detection alarmed on high Carbon Monoxide (CO) inside a High Pressure Distillation Column (T-1502)

4TH APRIL 2015

T-1502 HP Distillation Column

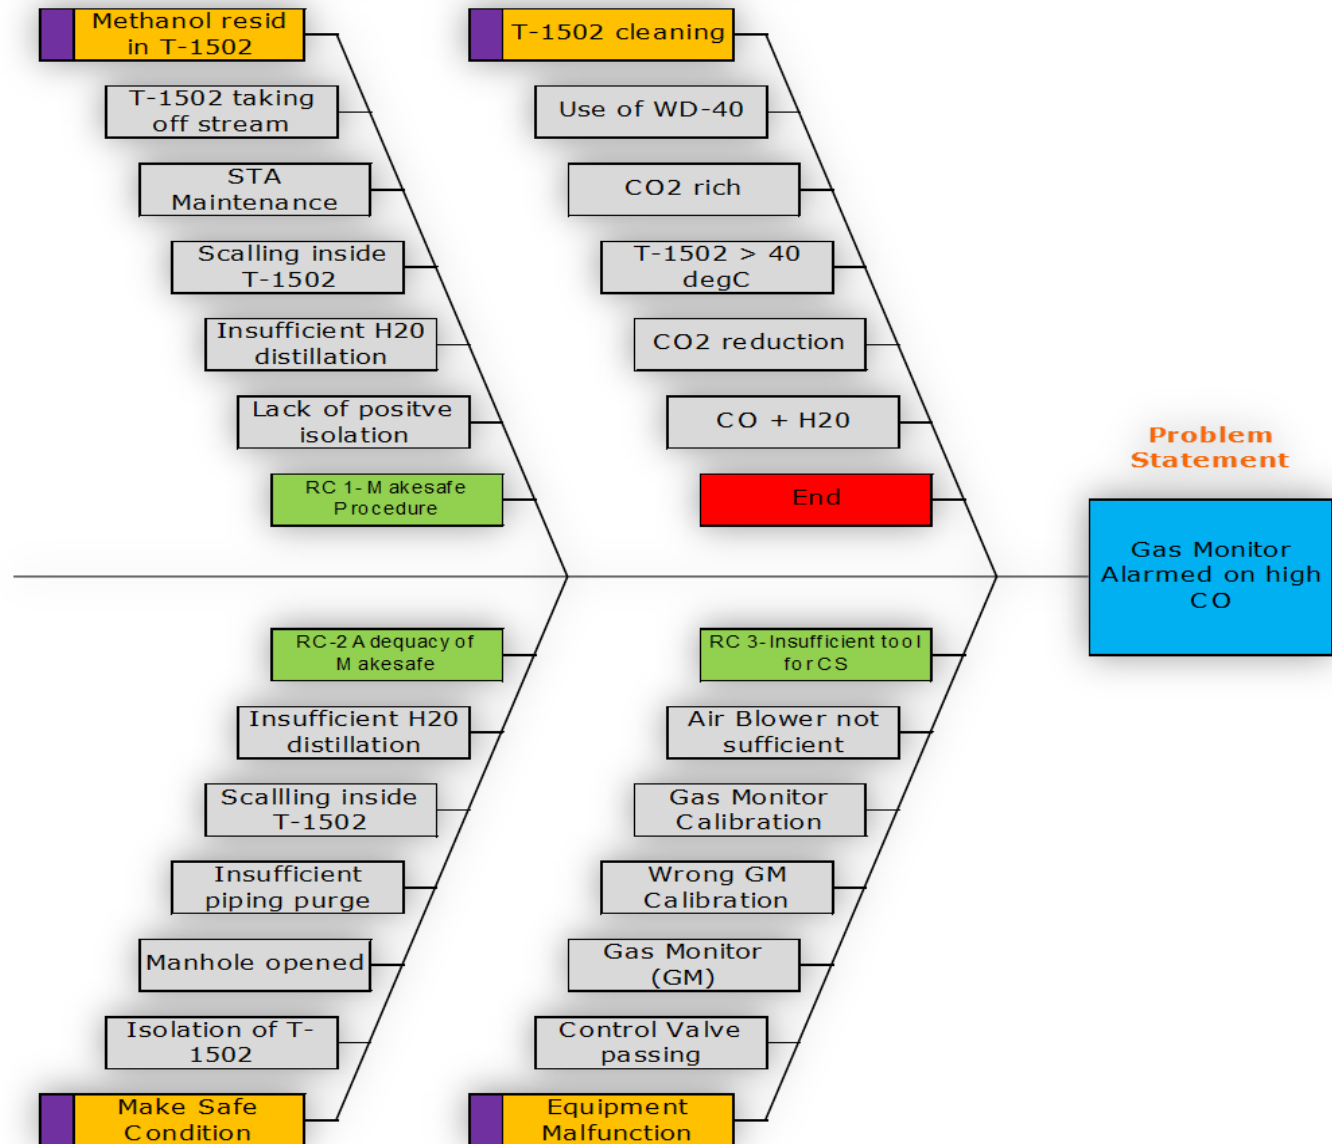
Event Cause Analysis

- Residual methanol was still being detected inside T-1502 and it was detected as CO by four head gas detection monitors when the column was ventilated with blower.

- ✓ Residual methanol was still detected inside T-1502 suggesting that the water (H₂O) distillation as part of the make safe condition of the vessel was inadequate.

- ✓ The isolation was made for the entire distillation section instead of providing positive isolation specific to HP Column unit as part of the make safe condition(refer to appendix for the marked up drawing) .

- Inadequate ventilation of the column
- ✓ There was no evidence to suggest T-1502 was continuously air purged after the make safe condition, although two air blowers (refer to figure 1&2) were used for the push and pull of air at the bottom and middle manhole.
- ✓ Air circulation was not continuous.
- ✓ Air blower was only used intermittently and the equipment was considered inadequate for that kind of service.

1. Update the make safe condition procedure to emphasize positive isolation for HP distillation Column instead of entire distillation section. (refer to Appendix 1)
2. Update the make safe condition procedure to include a minimum of 72 hours continuous push and pull air purge of T-1502 before entry.
3. Upgrade the four head gas monitoring device.
4. Include in the make safe procedure;
The use of Tiger VOC detector, as part of the make safe assurance from methanol residue.
5. Update the Incident Investigation Procedure to provide clear guideline for all near miss reporting and follow up.
6. Train the operations team on the updated near miss reporting protocol.
