## IMCA Safety Flash 16/13

October 2013

## 2 Fatality – Man Overboard

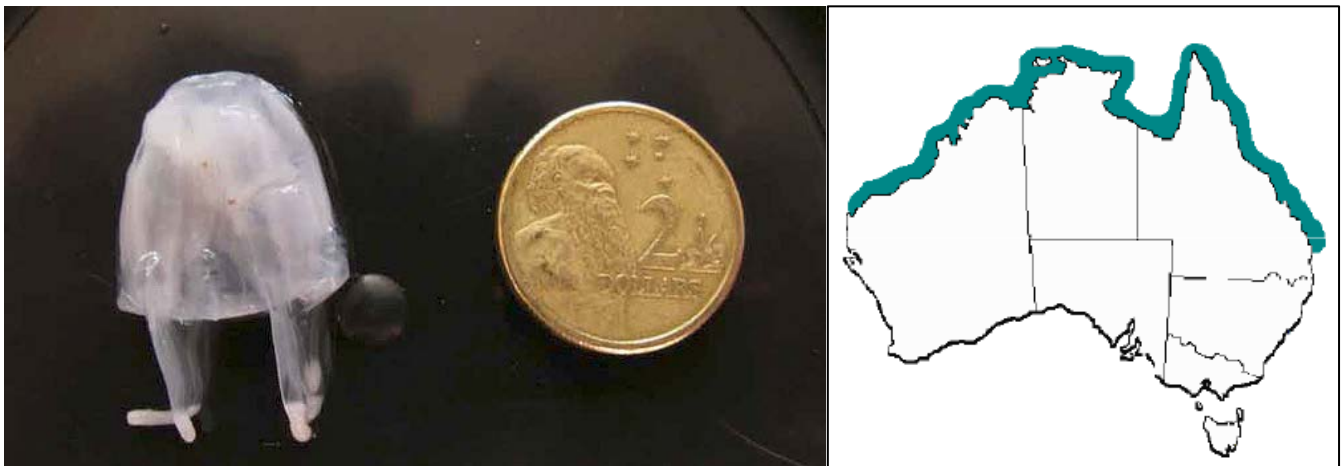
There are at least 10 species of Irukandji known, ranging from as small as 1cm to over 10cm in diameter; all are transparent and virtually invisible in water which makes them difficult for swimmers and/or divers to notice. Irukandji are most likely to be found in Australian tropical waters (see map). The normal Irukandji season begins from November through to May.

(L) Irukandji jellyfish (R) Areas in which Irukandji jellyfish are most likely to be found

Often the greatest threat is not to the diver but to tenders on deck handling divers' umbilicals and associated lines that have been submerged. Great care should be taken by topside personnel, paying particular attention to covering exposed skin by wearing gloves and long sleeve coveralls at all times.
