## Grating Incident resulting in LTI

# Incident Description

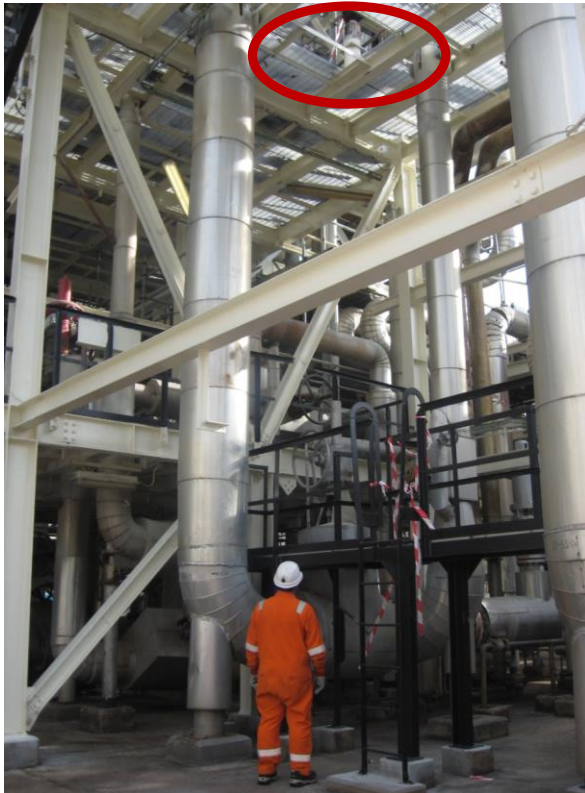
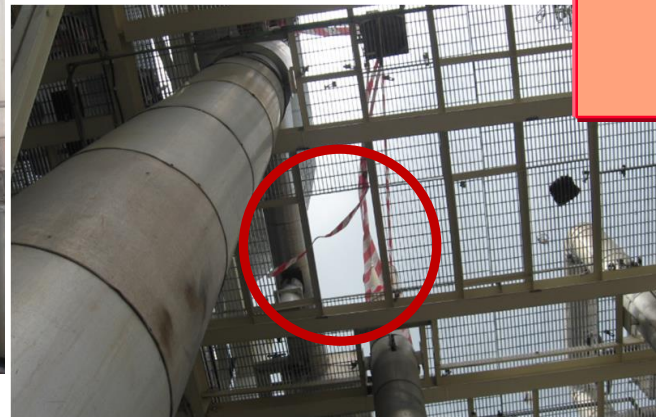
**A worker was injured when grating gave way**

No support found on the other side of the grating.

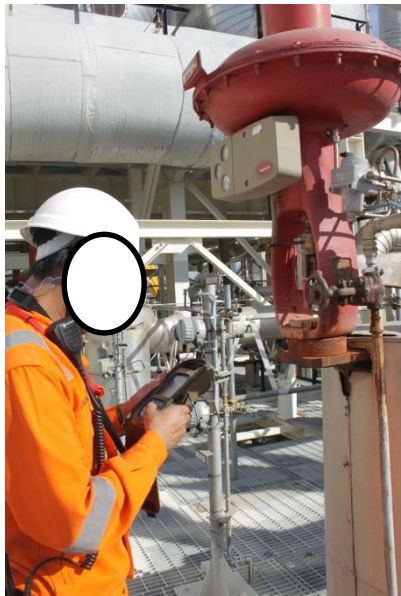
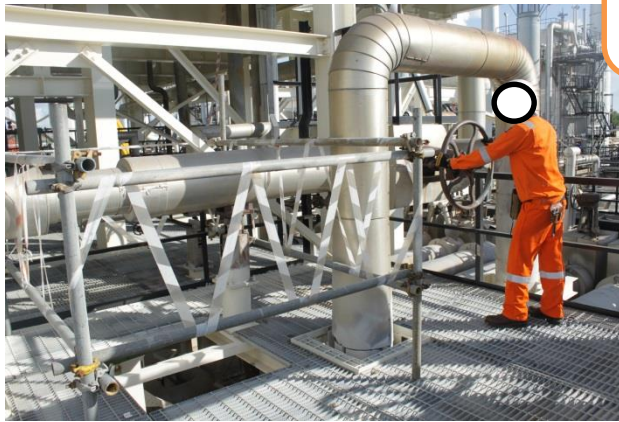
Operator's Daily Rounds at D5203

Grating clips found lying on the platform, level 2 of D5203, where Operators do daily rounds and take daily readings of LANCO valves.

Grating Clips found on the platform
